CHEDDAR GORGE FLOOD RELIEF WORKS

LONGWOOD VALLEY

PROJECT REPORT

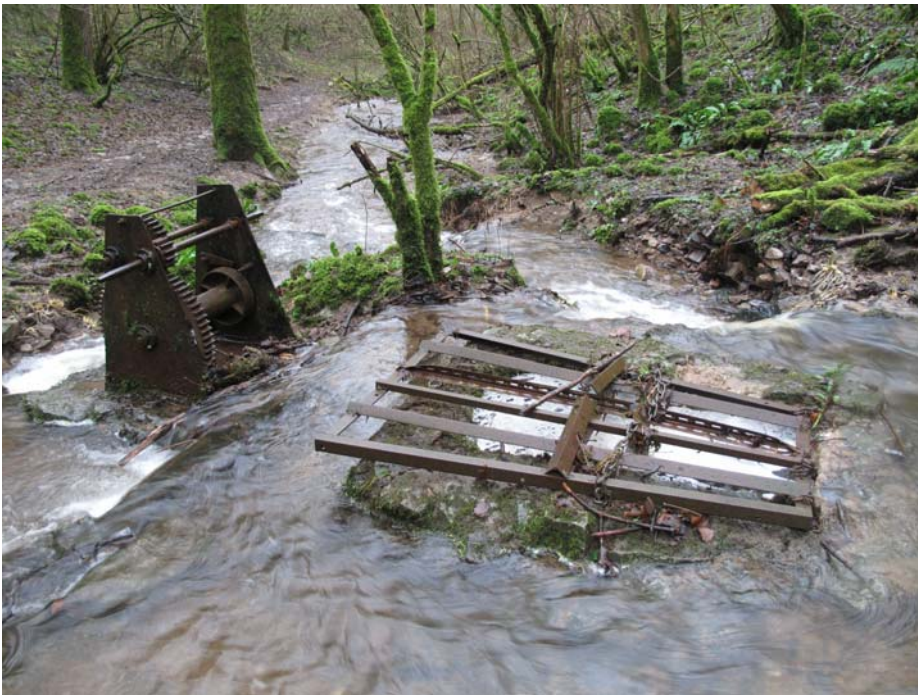
Water filling Longwood Valley sink and flowing off down the valley.

On 13th February 2013, local caver Rich Witcombe was able to relocate an entrance to a short section of cave passage known as Longwood Valley Sink that had been hidden under the bank of the valley for in the region of 20 years since a dig there was abandoned. With the assistance of cavers Ali Moody, Clive North and Stuart McManus, together with Bob Corns from Natural England and Chris Billinghamurst (volunteer reserve warden for landowners, Somerset Wildlife Trust), the entrance was dug out down to the level of an old grill and the stream was dammed to divert it down this sinkhole, preventing the water running down to Black Rock Gate. The

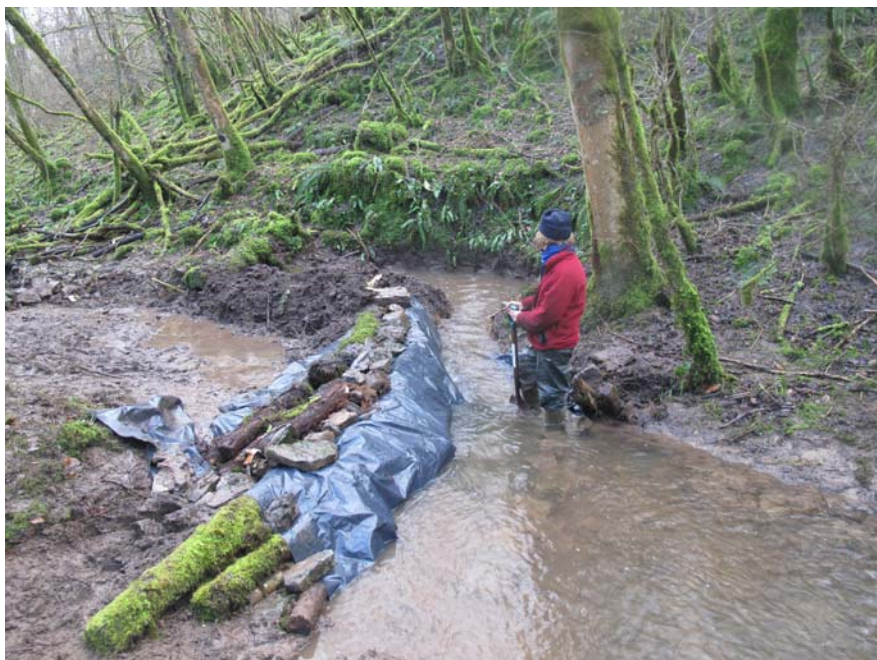
The first temporary dam at Longwood Valley Sink.

In addition, permission would be sought from Natural England to construct a permanent dam in place of the temporary structure and to allow work to take place in Longwood Valley Sink to replace the crumbling metal oil drums with a new plastic entrance pipe.

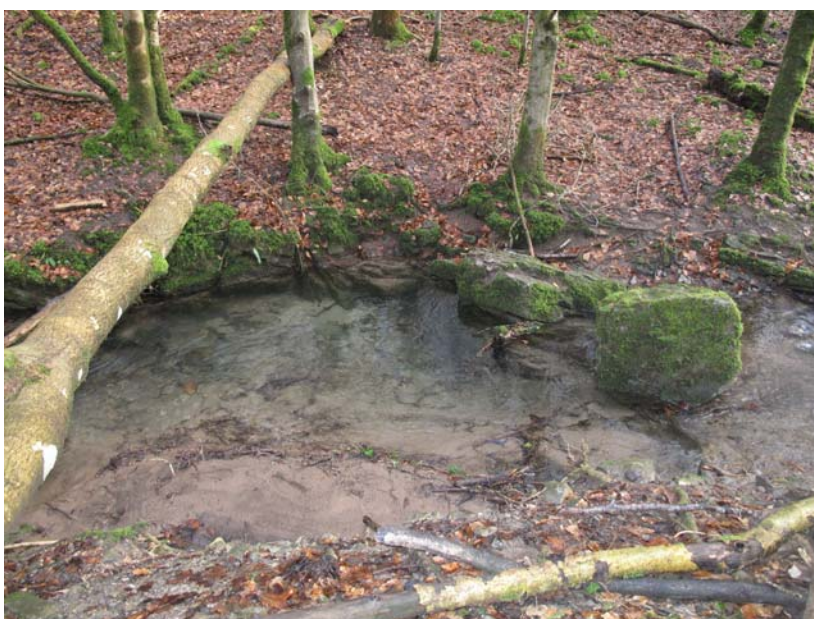
Longwood Main Sink, silted up and flooding - April 2013.

several days and finally uncovered the top of the enormous tree trunk that ended up in the swallet some 20 years ago, which meant that over time, debris consisting of wood, stones, leaves and silt had built up in layers until the sink became totally blocked.

After numerous digging trips consisting of the core team as above, plus some additional help, the swallet has now been lowered to the depth it had some 30 years ago and it is envisaged that this will now take all the water in all but the most extreme weather conditions.

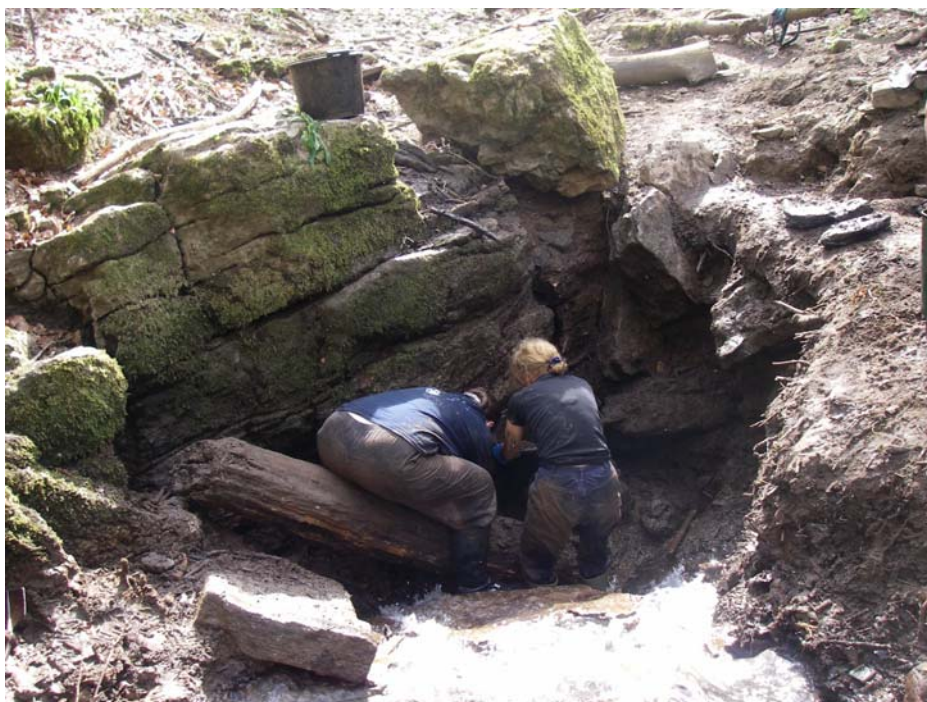
Clearing the Main Sink - May 2013.

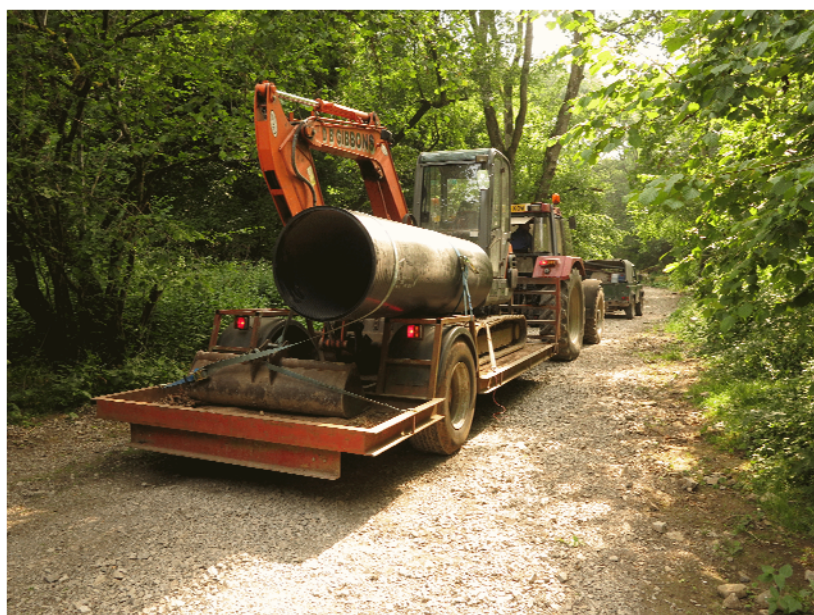
Digger and piping being transported to site - July 2013.

D.G. Gibbons, Contractors, supplied a large digger, and the pipe was transported up to LVS on a Land Rover. Thanks to the skill of the digger driver, Kevin, the old pipework was removed and a larger hole was excavated in order to install the new pipe. This was by no means an easy task at any stage of the work, but the combined efforts of the caving team from CCC, Neil Watson from SWT and Kevin, ensured that the

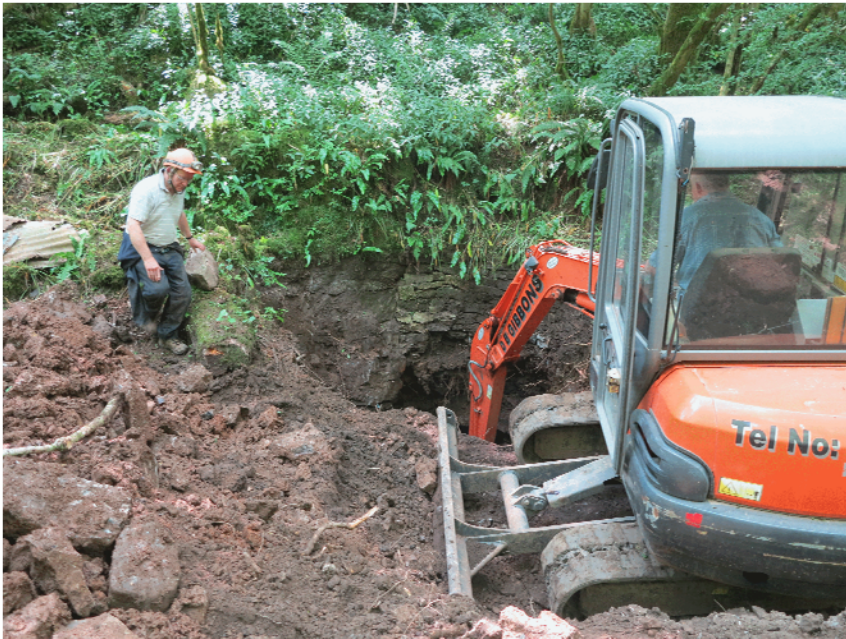
The digger in action - July 2013.
Photo: G. Price.

job was completed in two days rather than three, and the area around the new pipe was back-filled and the stream bed was deepened to allow for the building of a dry stone wall in accordance with the plans submitted to Natural England.

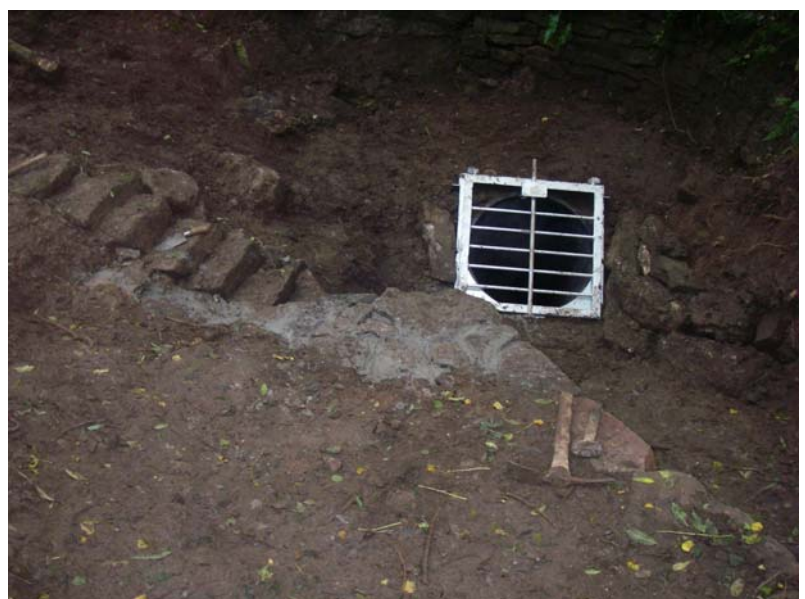
Longwood Valley Sink debris grill and gate.
Photo G.J. Mullan

A permanent gate, incorporating a debris grill was needed for the entrance to LVS. This was made by local metalworker Dave Speed, transported to site and installed on 27th September 2013. This took another full day's work by both cavers and Somerset Wildlife Trust, and at the same time, a final day's work was carried out at the Main Sink, to lower the level by about a further metre, in readiness for the winter weather. The final section of stone walling was finished, and other large rocks were strategically placed around the entrance.

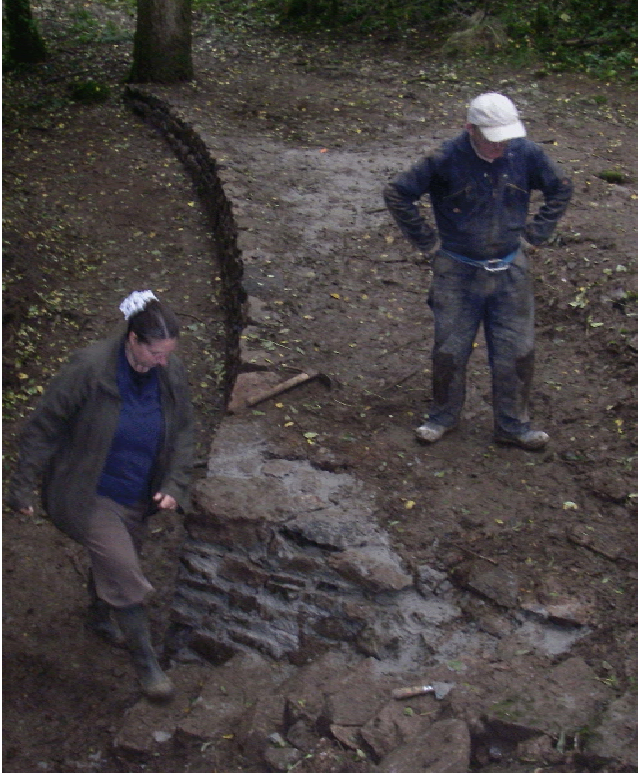
The permanent dam - September 2013.

This phase of work was carried out over the summer months by caving volunteer, Rich Witcombe, working with the aid of Clive North, another caver. A dry stone wall was built in a

long, gentle curve, leading down to the new piped entrance to Longwood Valley Sink, with a flight of steps leading down to the stream bed and the entrance. Behind the wall is a bank. This has provided a permanent replacement for the original temporary dam.

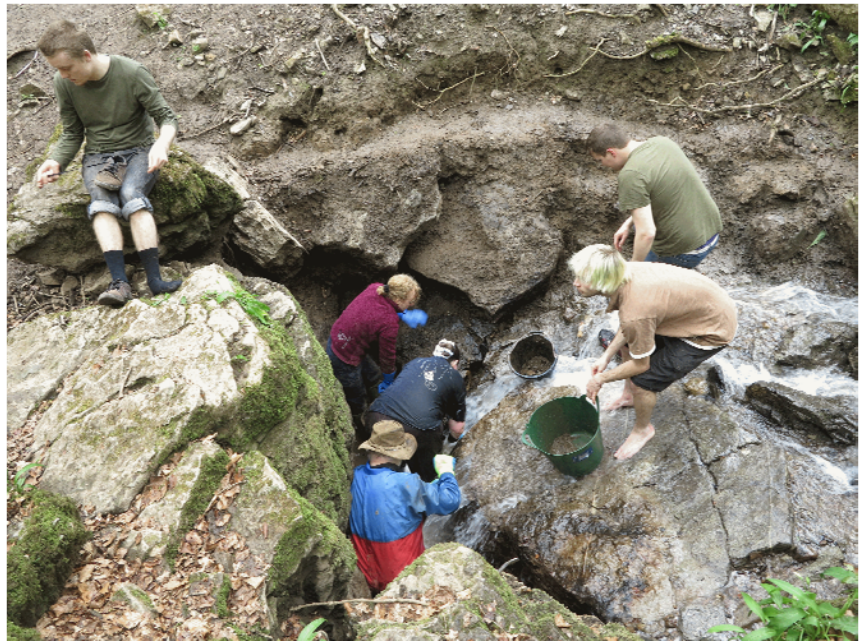
Cavers digging the Main Sink - May 2013.
